## **Report No. 14450/08-A1**

### **Tensile tests and bending test on profiles**

WALL-PROFILE GmbH  
Fürstenrieder Straße 279 a - 81377 München

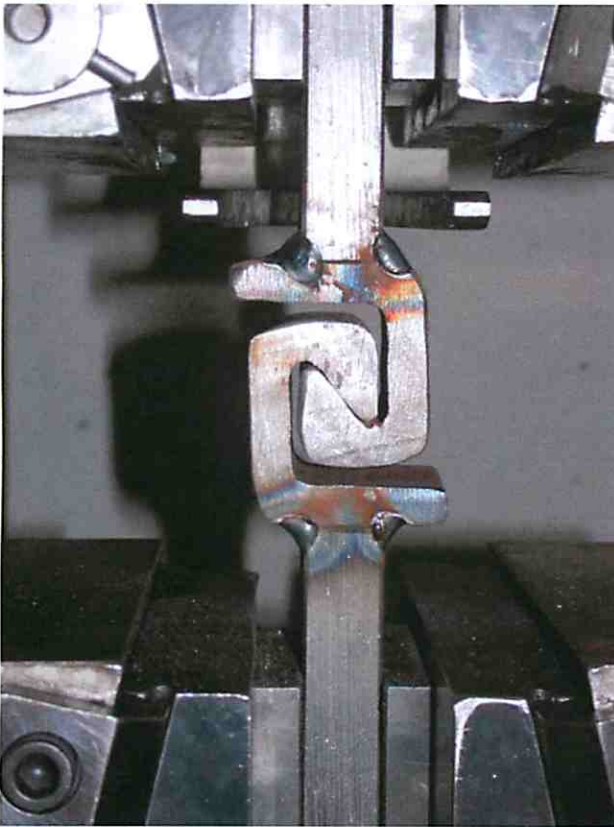
Photo 1.1:

Specimen 1  
Before the tensile test

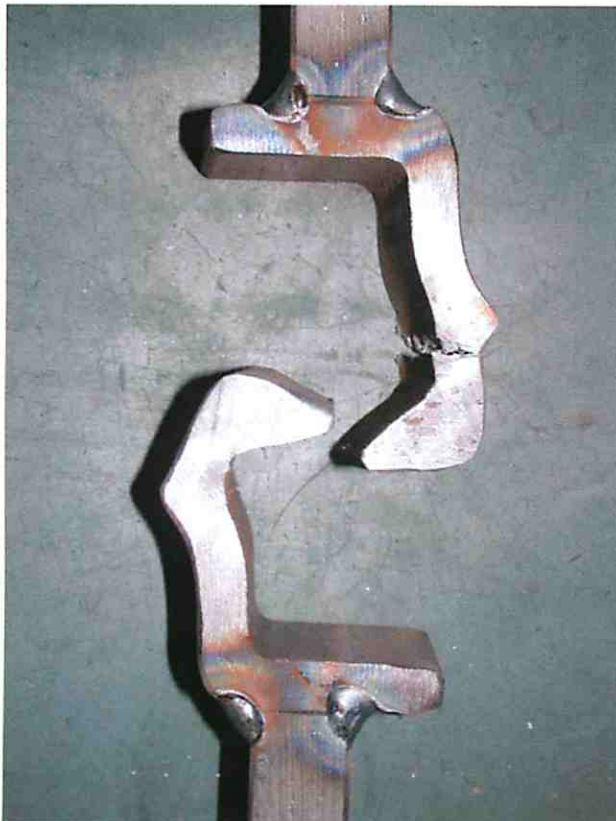
<b>Specimen No.</b>	<b>Tensile force in kN / lb</b>	<b>Length of sheet pile wall section in mm / in</b>	<b>Calculated tensile force in kN/m / t/m / kip/in</b>
1	60.2 / 13533.5	49.5 / 1.949	1216.2 / 124.0 / 6.94
2	169.3 / 38060.1	49.6 / 1.953	3413.3 / 348.1 / 19.49

Specimen 1  
After the tensile test  
Bent and broken open

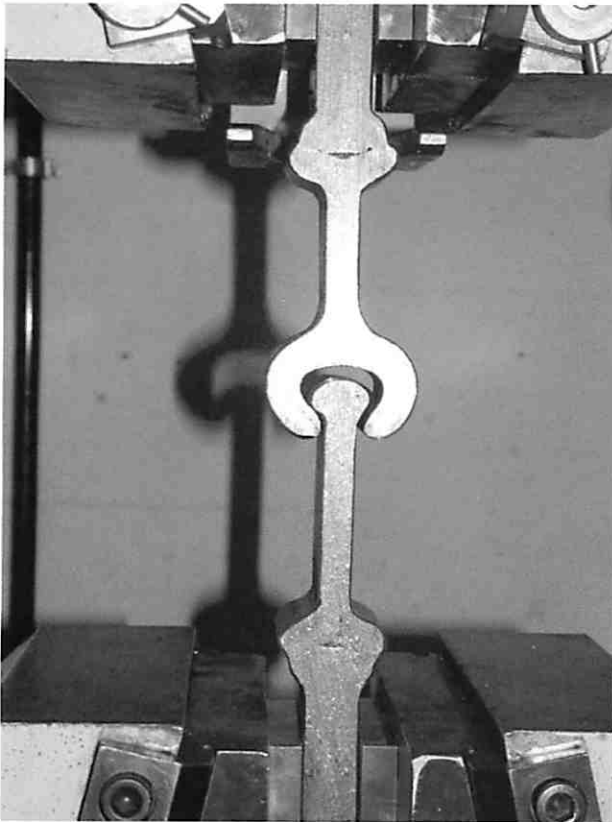
Photo 2.1:

Specimen 2  
Before the tensile test

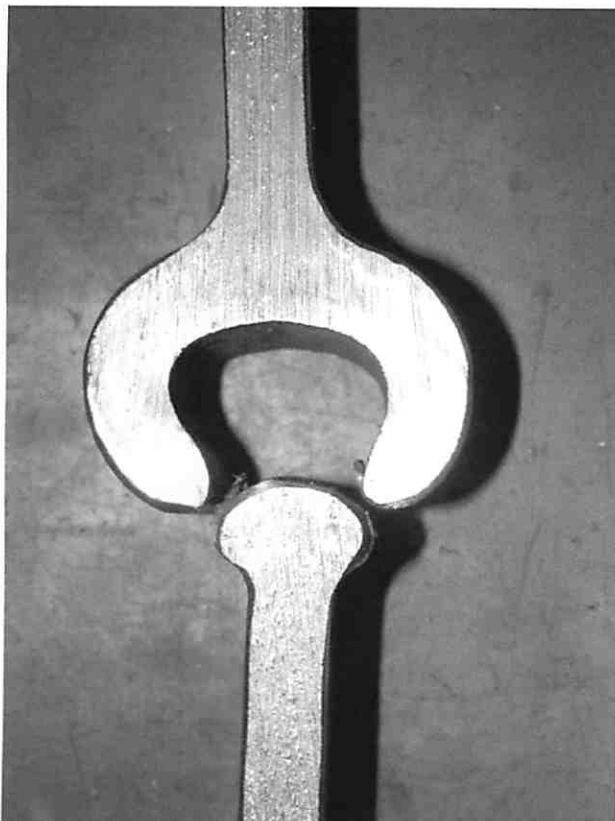
Photo 2.2:

Specimen 2  
After the tensile test  
Profile bent open at top

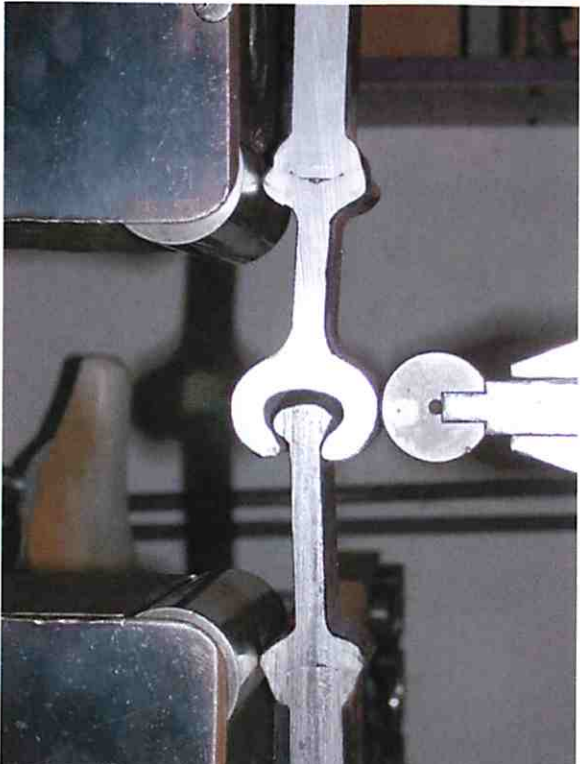
Photo 3.1:

Specimen 3

Before the bending test  
Supported at the outside at the  
end of the profile

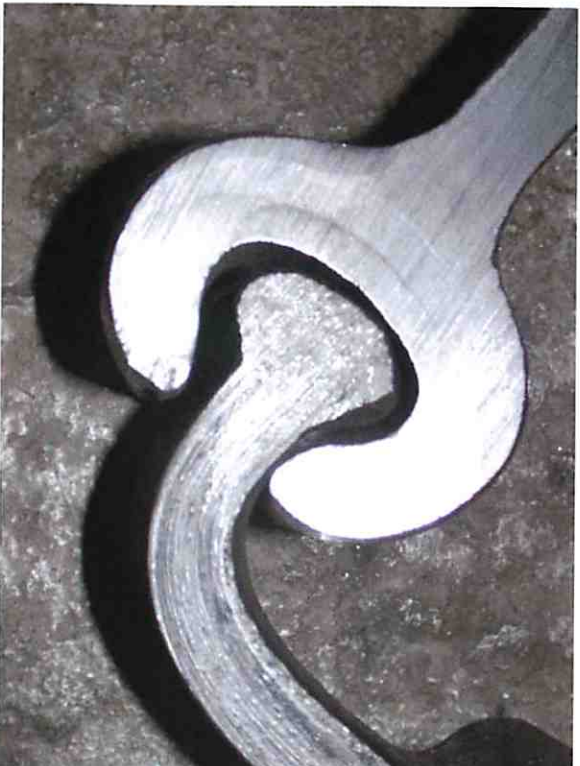
Photo 3.2:

A bending test was to be conducted on the profile combination WOM-XL100 with WOM-XL105. The result of this test was that the specimen had been bent up to approx. 90° without any negative finding. Photo 3.1 in the enclosure depicts the component before the bending test and Photo 3.2 in the enclosure depicts the component after the test.

Specimen 3

After the bending test  
Approx. 90° no break or starting  
fracture
